HISTORIC STRUCTURES REPORT

OLD NORTH CHURCH

ARCHITECTURAL DATA

BOSTON NATIONAL HISTORICAL PARK

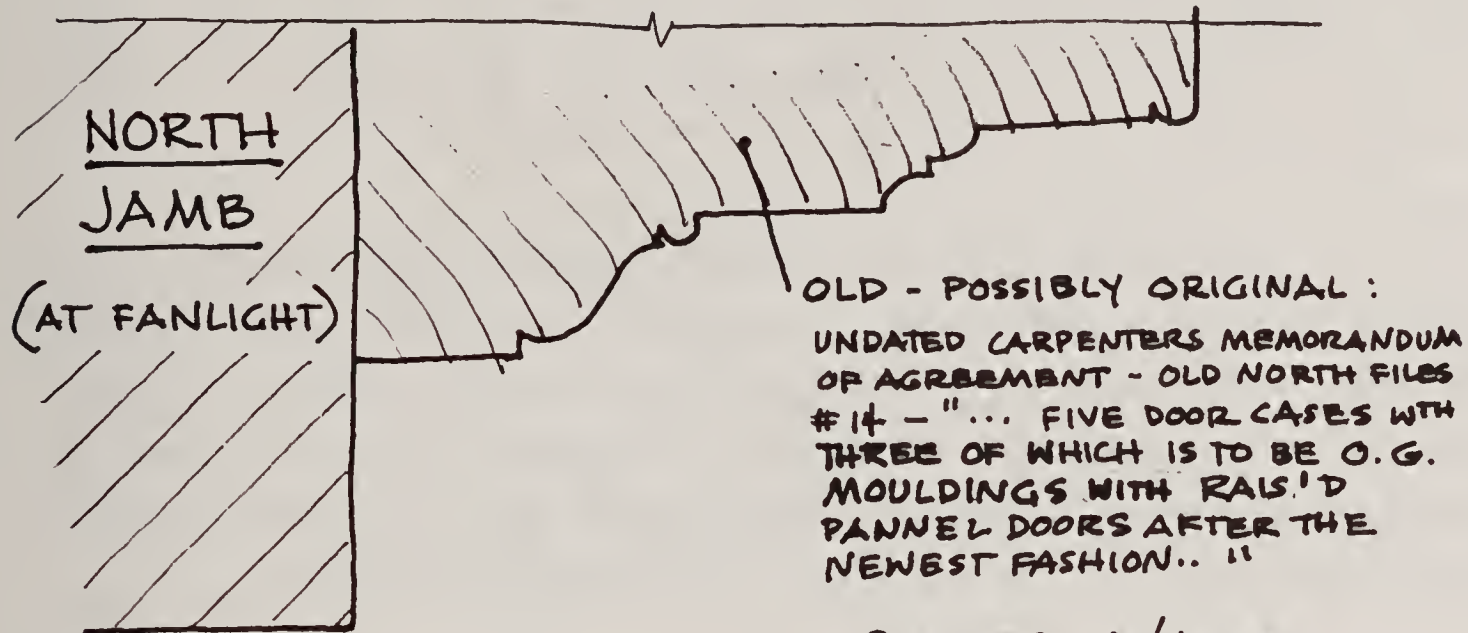
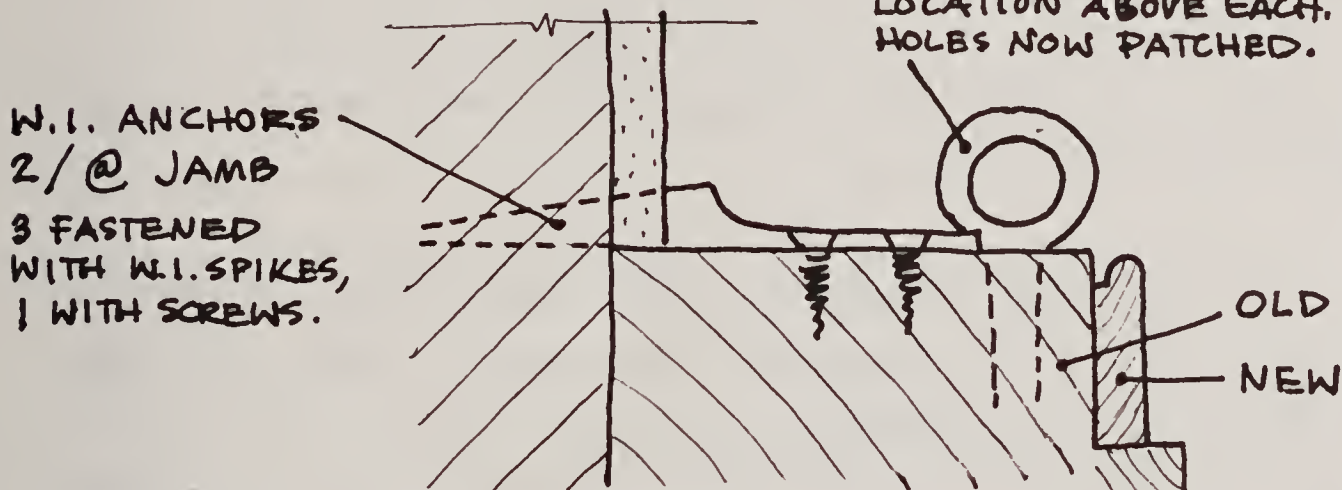
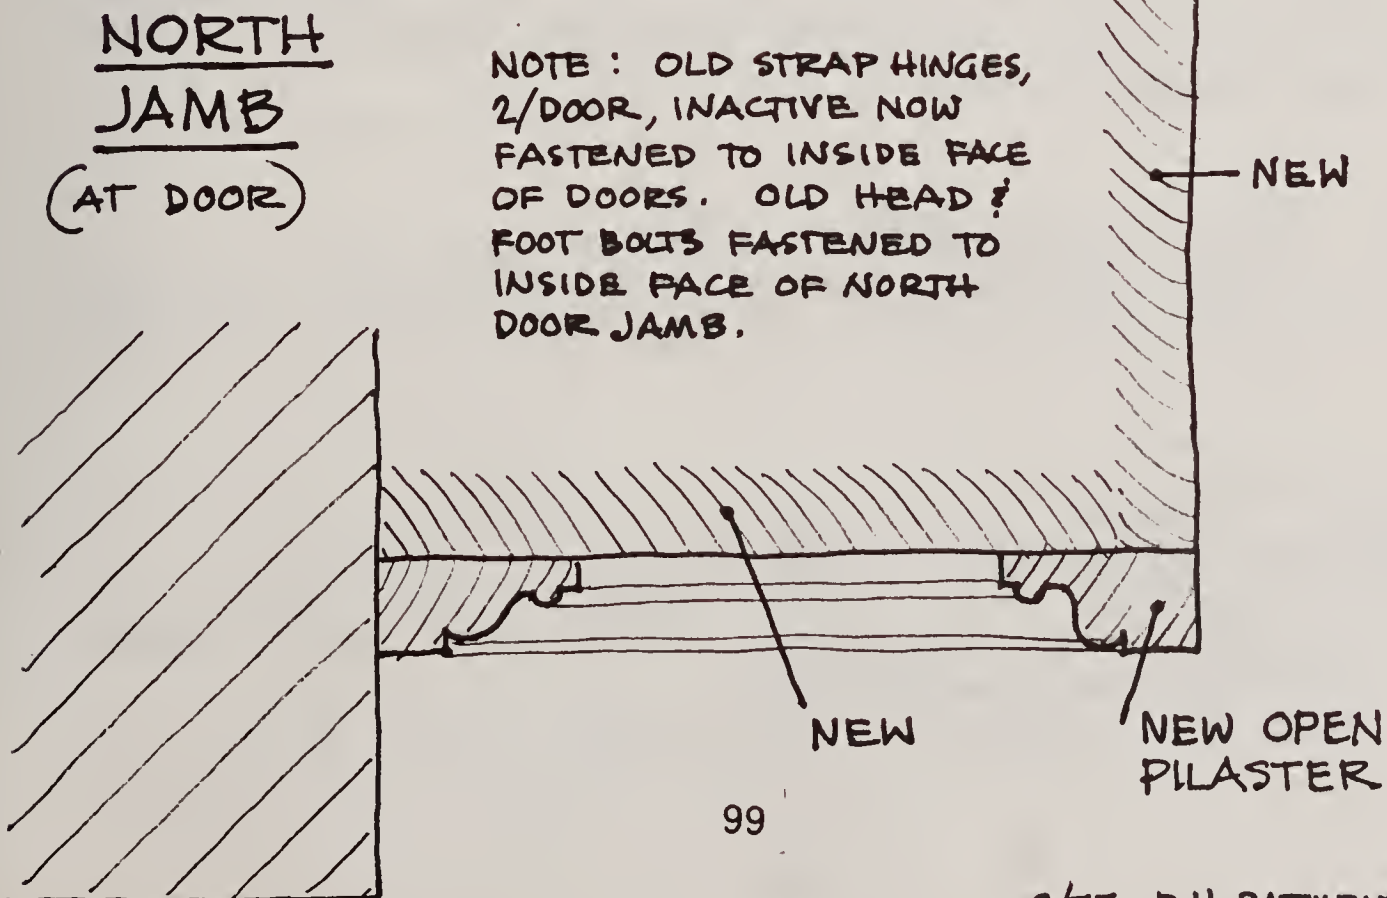
OLD NORTH CHURCH TOWER ENTRANCE DOOR FRAME

What the arched area originally contained is a question, for the pre-1869 photograph seems to show remnants of the active doors crudely adapted to fit the arched opening. The doors were cut on a curve right through the stiles and panels and were installed without the benefit of a curved rail to fit the arch.

The frame (see the sketch included here) seems to be original in the arched area. At some time before 1869, impost moldings were added at the exterior face with open pilasters below. Originally the architrave which now surrounds the arched head of the door probably continued uninterrupted down the jambs butting into plinth blocks at the sill level, or extending to the sill.

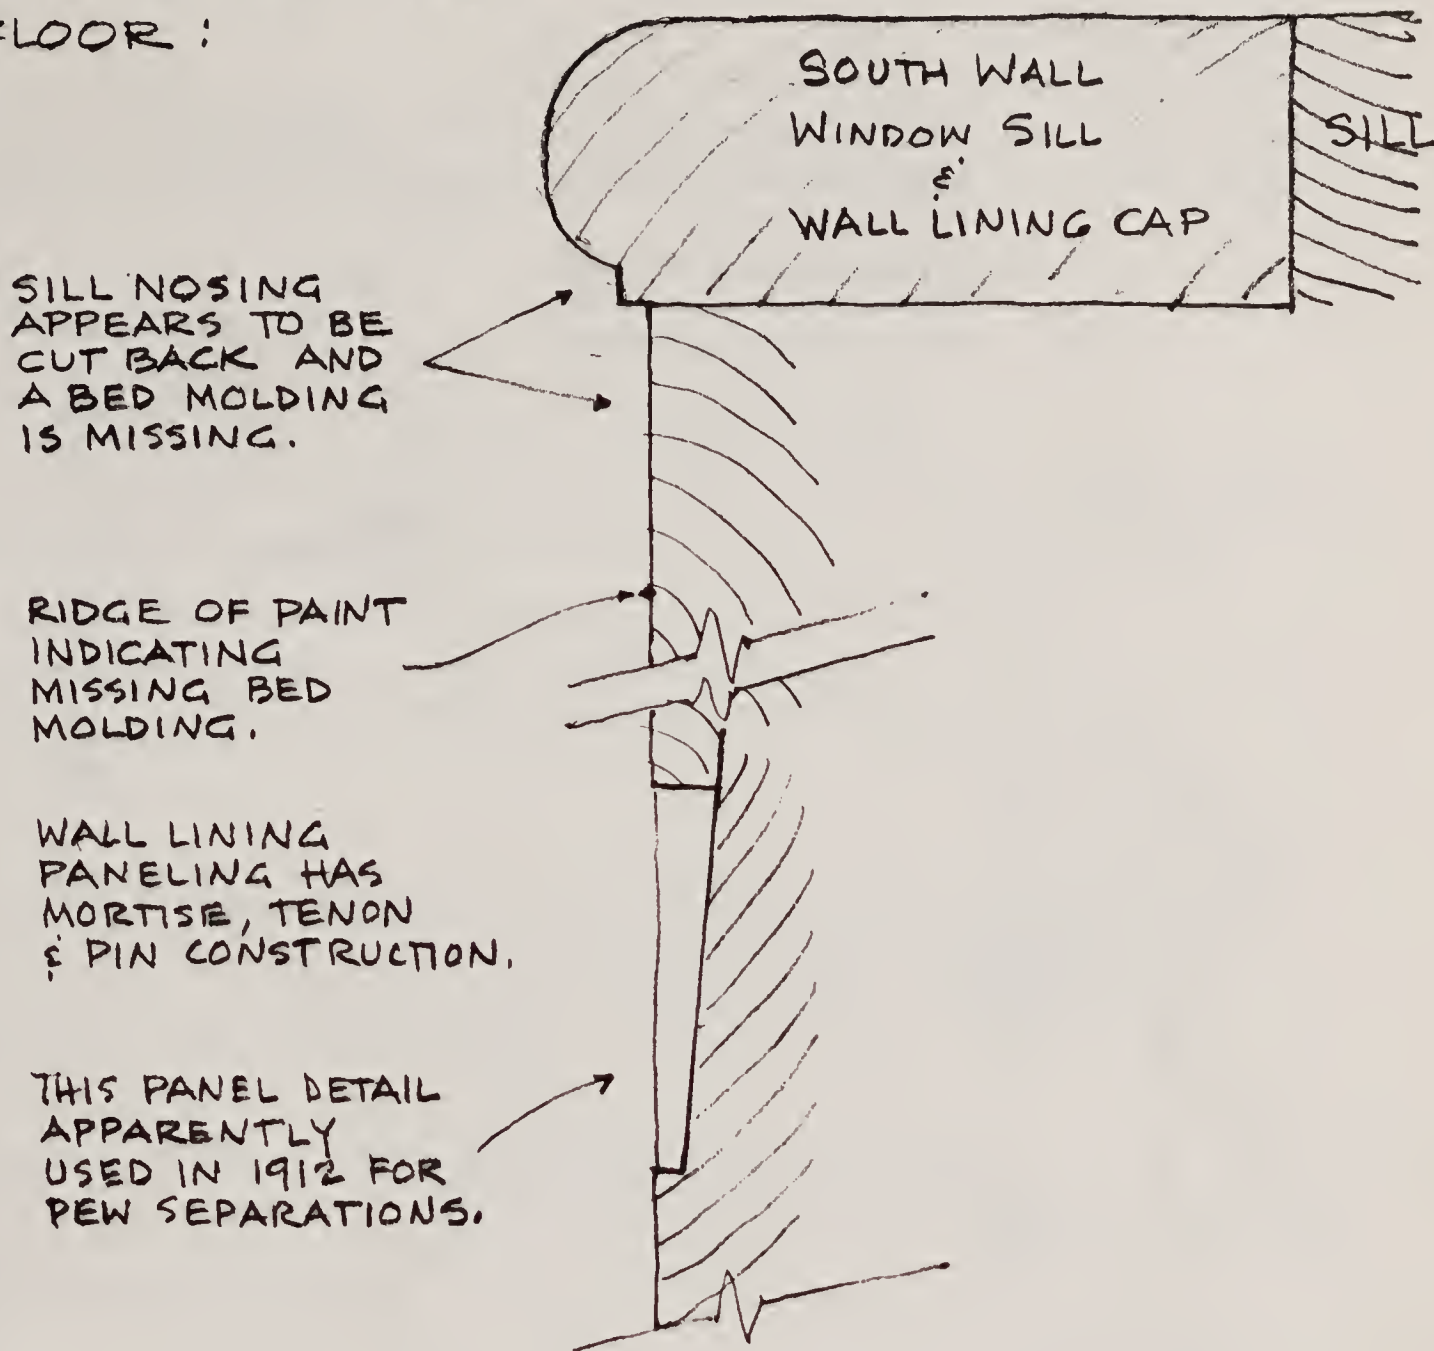
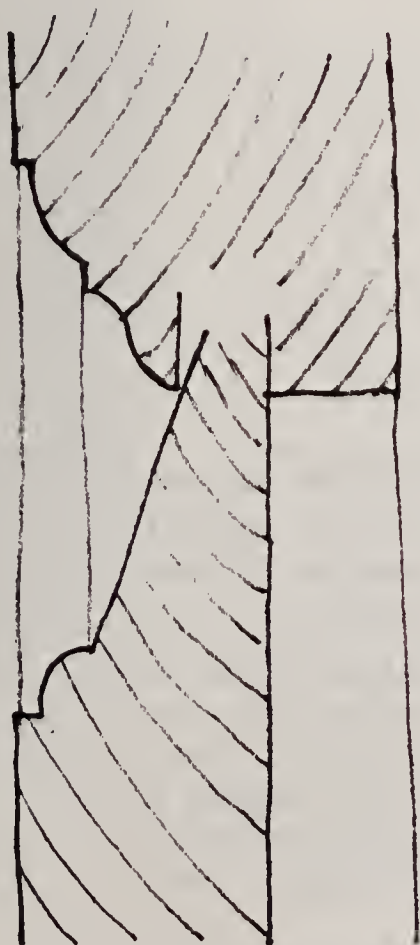
PEW DOOR - SOUTH AISLE - MAIN FLOOR

NOTE : DOORS HAVE BEEN
REHUNG - SOMETIMES WITH THE
HAND CHANGED.

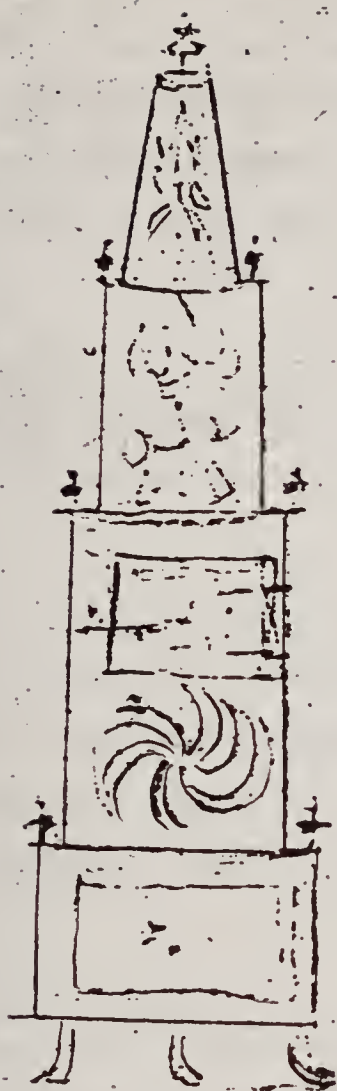
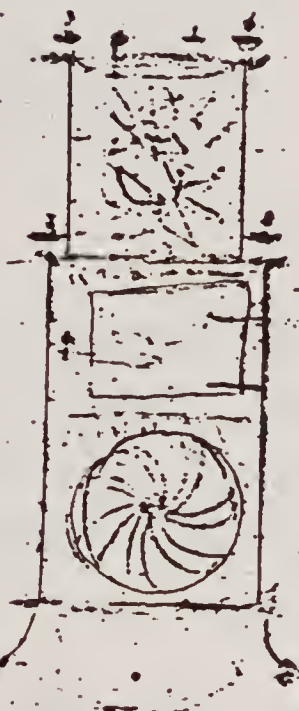
Pencil sketches of stoves which may have been supplied c. 1834 (The paper was found among bills and receipts of this period at Old North Church). Two and four tiered, with brass finials at each level, these stoves stood on decorative feet, had embossed cast iron plates to increase the radiation surfaces, hinged doors at the fire boxes and large adjustable dampers.
